**DuOtherm Warm Roof on Concrete
Monkey Toe Walkway Fixing Detail**

Drawing No:	DBDTC-D12
Scale:	1:4 @ A4
Drawn by:	NKT
Date:	30/10/2017

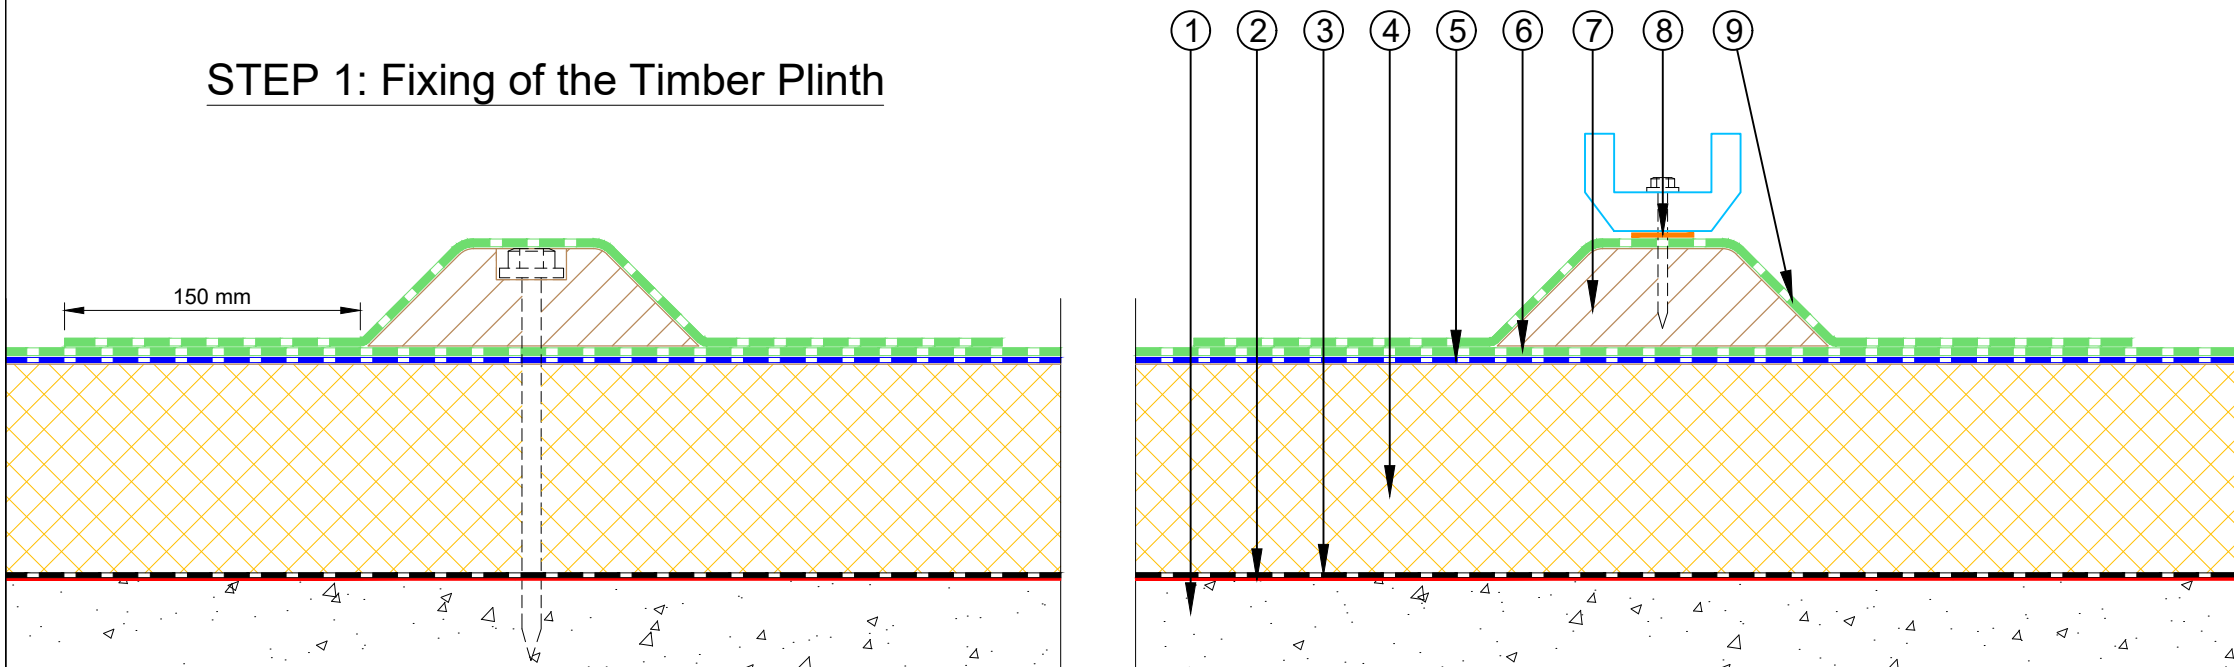
- ① Concrete Roof Slab laid to fall
- ② Equus/De Boer DuO Primer
- ③ Equus/De Boer Vapour Barrier
- ④ Equus PIR Thermal Insulation Board
- ⑤ Equus/De Boer Basesheet
- ⑥ Equus/De Boer Capsheet DuO HT 4 Slates/F C180 FireCare
- ⑦ Timber Plinth
- ⑧ Monkey Toe Roof Profile Fixing with Neoprene Washer
- ⑨ Equus/De Boer Capsheet, as separate piece over Timber Plinth

STEP 2: Fixing of the Monkey Toe Roof Profile

STEP 1: Fixing of the Timber Plinth
